MORE THAN 50 YEARS OLD, THE HISTORIC BRIDGE IN PITTSBURGH REQUIRED REHABILITATION.

## JACK'S RUN BRIDGE REHABILITATION

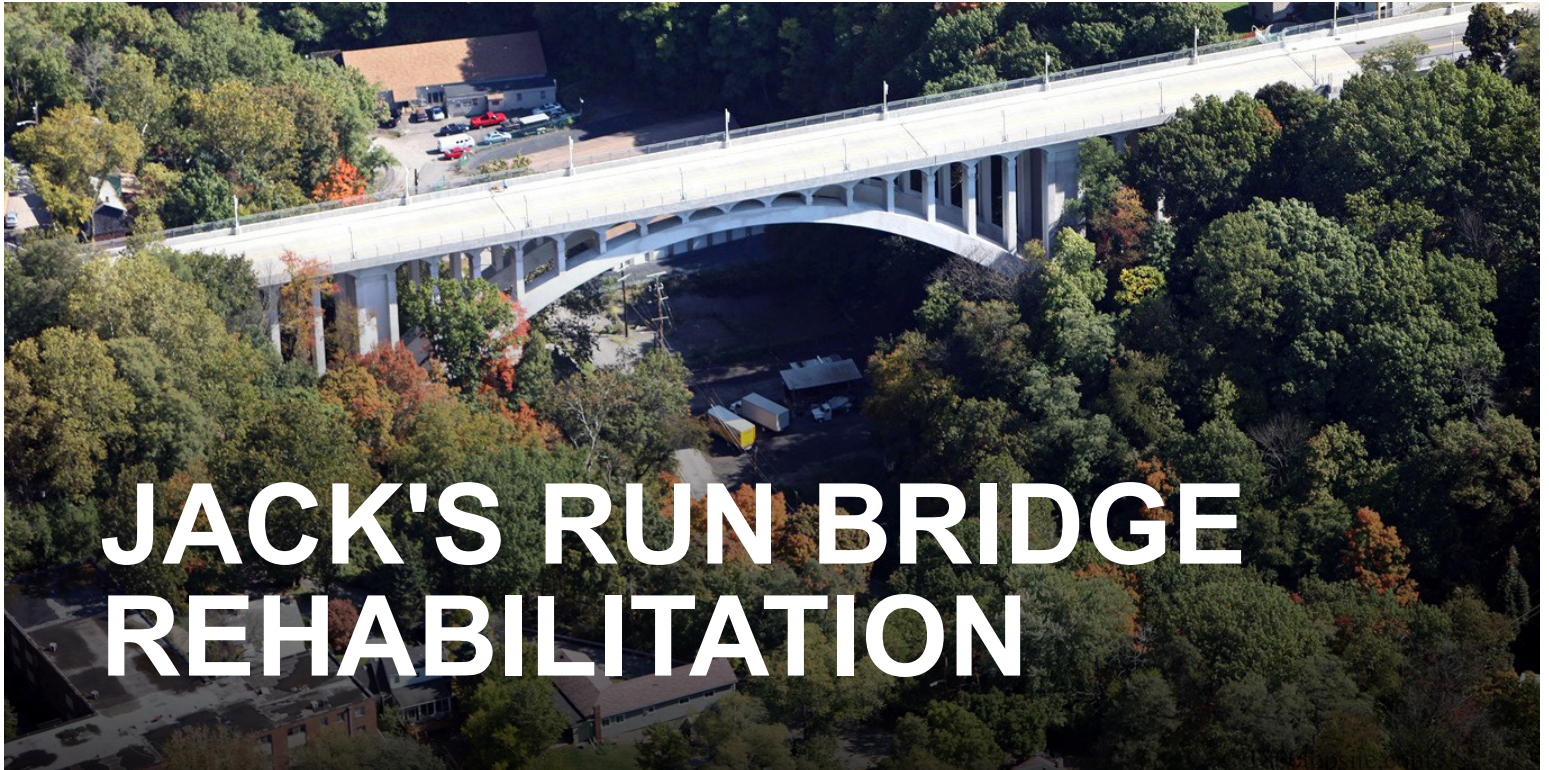
Located in the Borough of Bellevue, in Allegheny County, Pennsylvania, Jacks Run Bridge carries vehicles and pedestrians over a deep ravine that cuts through the neighborhood.

spans, 15 feet to 20 feet long, and a 320-foot-long main span. Jacks Run Bridge accommodates vehicle traffic with a two-lane roadway with 7-foot shoulders and two sidewalks for pedestrians.

This project involved the rehabilitation of an open spandrel concrete deck arch, built in 1926. At a total length of 590 feet, the deck arch includes 14 approach
